Bonding plastic handles onto metal broom poles

Objective To heat a 0.85" (21.6 mm) outside diameter magnetic steel tube to temperature to melt plastic handles onto metal broom poles.

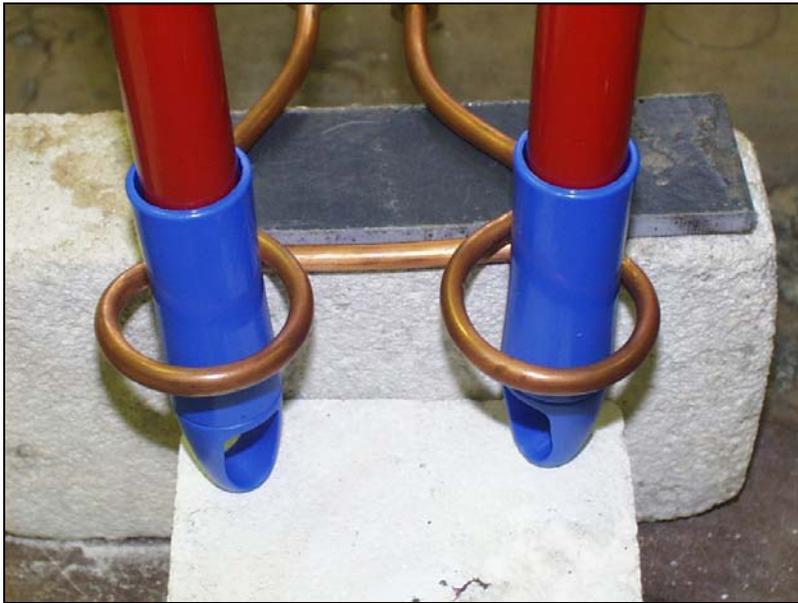
Two assemblies (plastic handle and broom pole) in the two-position coil

Process A rate of 25,000 parts per eight hour shift was desired, with two parts heated at the same time inside the coil. Plastic caps (handles) were placed on steel tubes (broom poles). The two tubes were inserted into the two-position coil and heated for 800 milliseconds. The tubes were then removed and set aside to cool. Once the tubes had cooled, the plastic caps were pulled by hand to ensure they had melted onto the tubes as desired. The handles had in fact bonded to the broom poles.

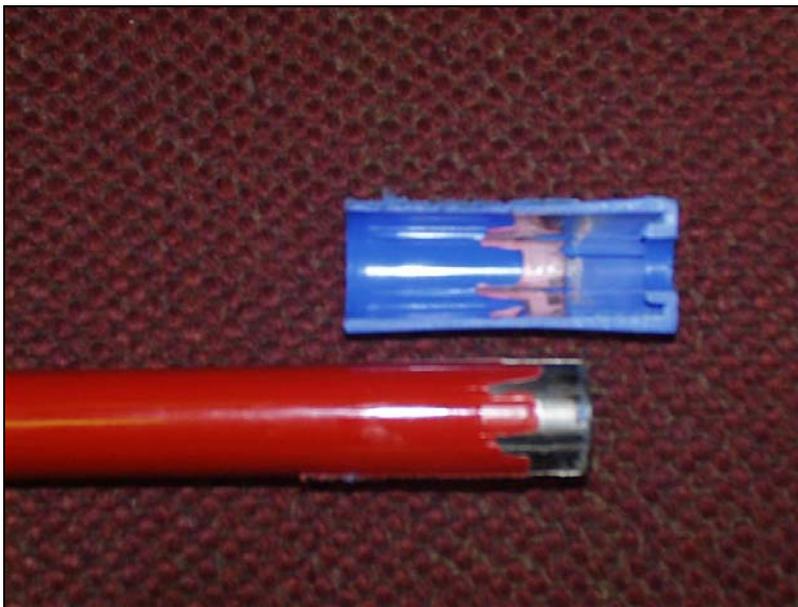
After heating, the assembly was cut by a saw to show where the plastic melt occurred
